Fracture Toughness in Bulk Materials

Introduction

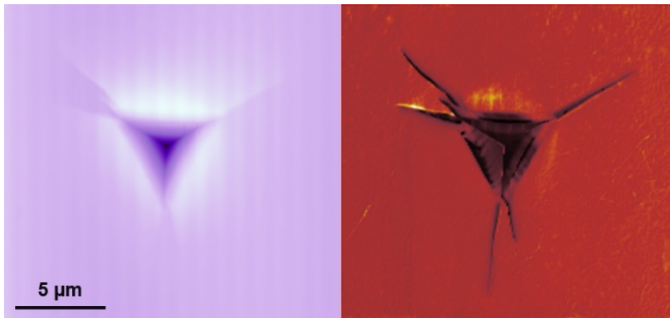
Figure 1 shows images obtained by using the scanning and stiffness mapping methods on the KLA G200 NanoVision stage. The left image was generated by scanning a silica indent and shows the surface topography of the residual impression as well as cracks at each of three corners propagating across the surface. The right image was generated using stiffness mapping and shows a more visible picture of the indent and cracks along the three corners. Stiffness mapping was also used to determine the crack length for the fracture toughness calculation.

Figure 1. G200 images of a silica indent using a NanoVision stage with the scanning method (left) and the stiffness mapping method (right).

Some shorter split cracks can also be seen in the corners, along with the three primary cracks that occurred by continuous increasing of the applied load during the later stages of loading. The primary crack lengths were used for calculations. The experimental fracture toughness for a maximum load of 100mN averaged over 10 repeated tests was measured as $0.74 \pm 0.09 \text{MPa}\cdot\text{m}^{1/2}$, which agrees well with the reported value for bulk fused silica, $0.79 \pm 0.01 \text{MPa}\cdot\text{m}^{1/2}$.

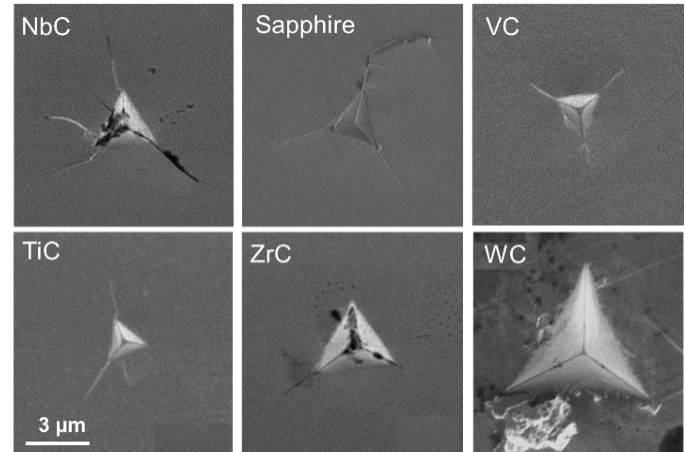
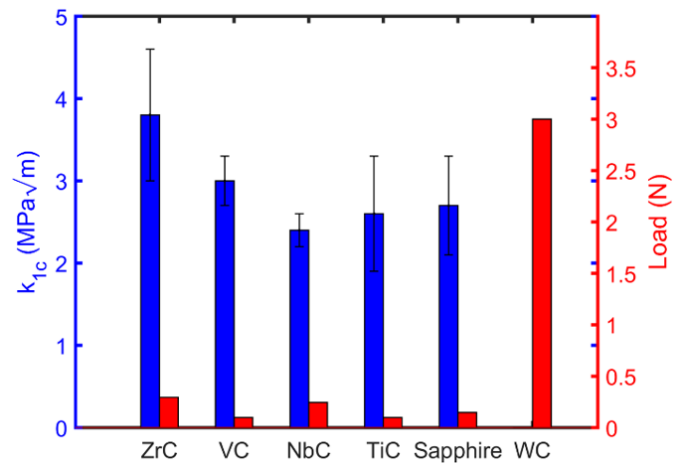
A series of extremely hard ceramic carbide materials were also tested using the same technique and their fracture toughness values were also calculated. In addition to high hardness and modulus, fracture toughness (resistance to cracking) of these materials is important because of their potential application as candidate tip materials for high temperature indentation. In Figure 2, the left set of SEM images show residual indentation impressions on these materials using a sharp Cube corner tip, with measured crack length between 2-10 μm . The chart at right shows the calculated fractured toughness K_c and applied load for each material, which includes niobium carbide (NbC), sapphire, vanadium carbide (VC), titanium carbide (TiC), zirconium carbide (ZrC) and tungsten carbide (WC). Interestingly, the single crystal WC does not show any visible cracking, even at loads as high as 3N.

Figure 2. (top) SEM images of residual impressions for six hard materials: NbC, sapphire, VC, TiC, ZrC, and WC; (bottom) calculated fracture toughness K_c and maximum applied load for the six materials.

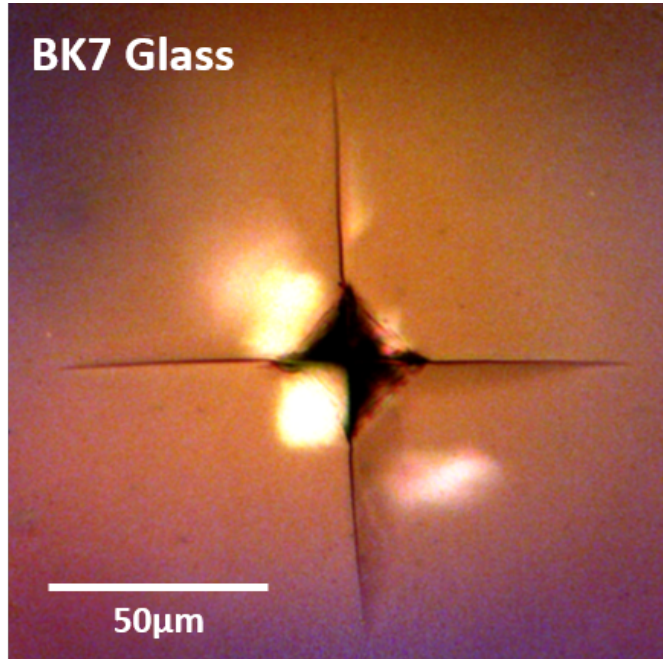
Schott BK7 (borosilicate) glass and Plexiglas (PMMA) were both indented using a Vickers tip. As shown in Figure 3, long radial cracks appeared along the indentation mark edges for the borosilicate for each of the four corners of the tip. The fracture toughness of Borosilicate was measured as $0.96 \pm 0.01 \text{MPa}\cdot\text{m}^{1/2}$.

Figure 3. Indentation of borosilicate glass using a Vickers tip.

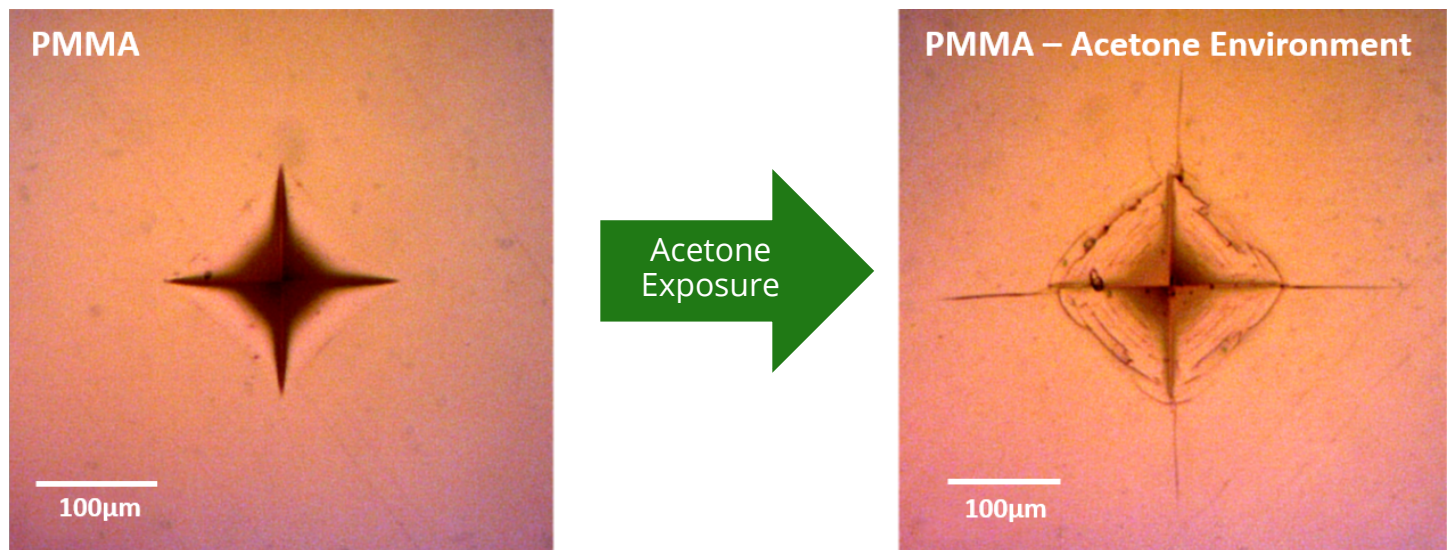
The PMMA indentation, shown in Figure 4 (left) does not show any sign of brittle cracking along the edges of sharp Vickers tip. Plexiglas, or PMMA, is a transparent plastic known for its shatter resistance and typically exhibits ductile behavior during deformation. However, if a material is exposed to different environmental conditions, extreme changes in mechanical behavior may occur. Indentation is an effective way to probe such surface changes. When the PMMA was exposed to an acetone environment during the indentation, cracks were

initiated and propagated from indentation corners, clearly showing environmentally assisted crack growth (Figure 4, right). This phenomenon is sometimes called stress-corrosion cracking.

Figure 4. Indentation of Plexiglass (PMMA) using a Vickers tip, under normal conditions (left) and exposed to an acetone environment (right).
